# High Performance Blade Evaluation

Final Report

**Project 1031542/CR18-02  
January 2023**

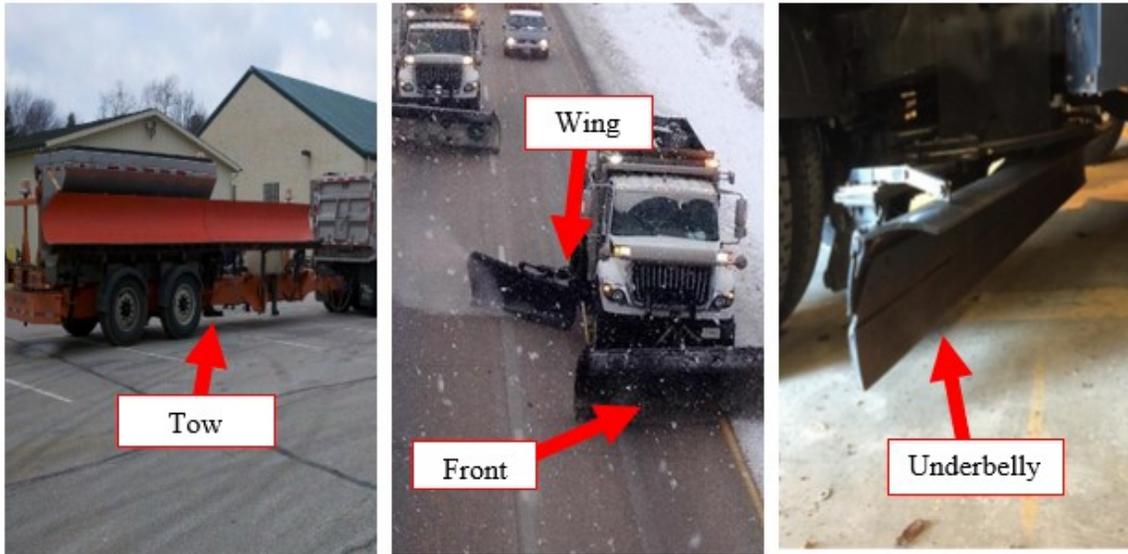
Figure 2-1: Tow Plow

Mechanical removal of snow involves relocating the snow/sleet from a roadway lane to the median or rumble strip to make a safe passage for drivers. Mechanical snow removal uses a plow that may be oriented in four ways: tow, front, wing, and underbelly as seen in Figures 2-1 through 2-3.

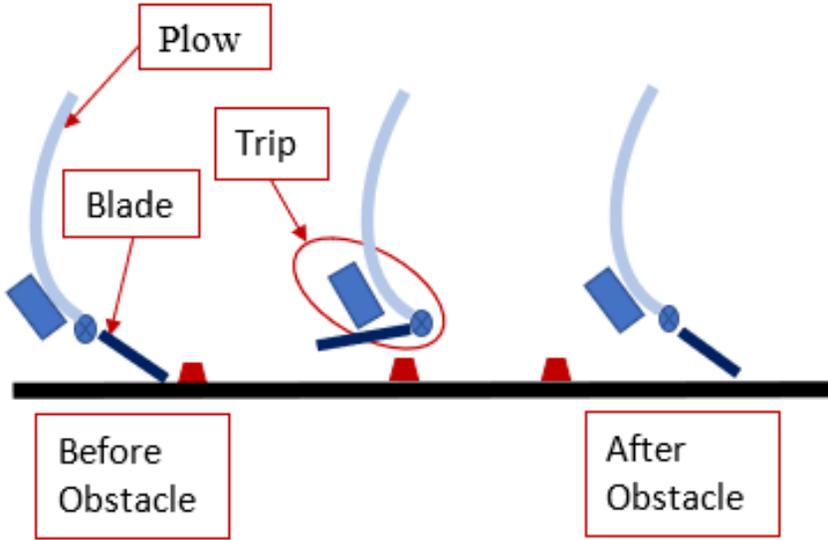
Figure 2-4: Tripping Mechanism

The first component that a front plow may have been a tripping mechanism. Tripping mechanisms are used to protect a snowplow from damage which may occur from obstacles in the roadway (Pell 1994). These tripping mechanisms either use a moldboard or a trip-edge blade to allow the blade to roll or float

once it hits an obstacle to reduce the risk of breaking (Day 2003). Figure 2-4 shows how a tripping mechanism helps a blade avoid damage from an obstacle.

Aside from a tripping mechanism, shown in Figure 2-4, snowplows have multiple components that assist in the mechanical clearing of snow and ice from the road. The other potential components on a snowplow may be seen in Figure 2-5.

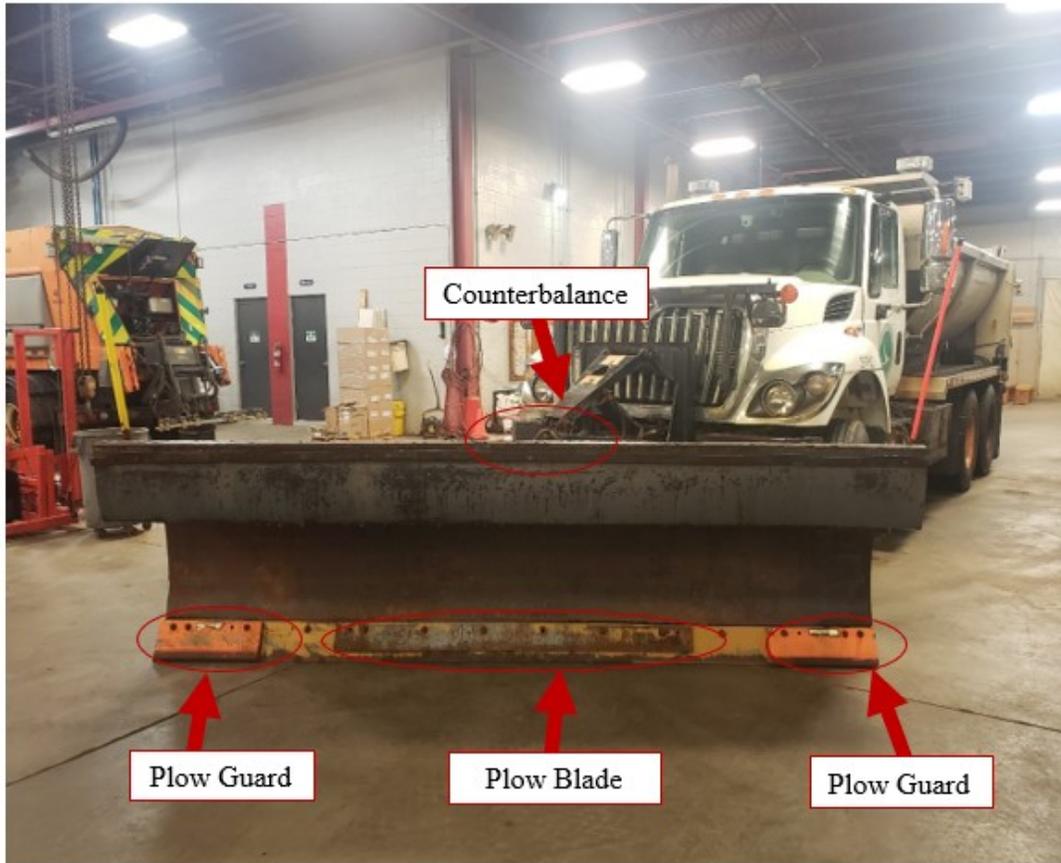
**Figure 2-5: Front plow**

The first component is the counterbalance which is used to offset the weight of the blade on a snowplow to ensure there is no tipping forward or backward dependent on its angle. The counterbalance engages a force that reacts to an opposite force to balance or limit influence of the opposite force. The second component is the plow guards. Plow guards are used to protect the plow blade from hitting obstructions and help reduce wear at the locations which they are placed. The third component is the plow blades. The plow blade is the component which experiences the greatest amount of wear due to the blade being in direct contact with the ground (Schneider et al 2015). A typical plow blade for DOT uses two generic orientations: a straight blade or an articulated blade. Figures 2-6 and 2-7 show the two orientations of a plow blade.

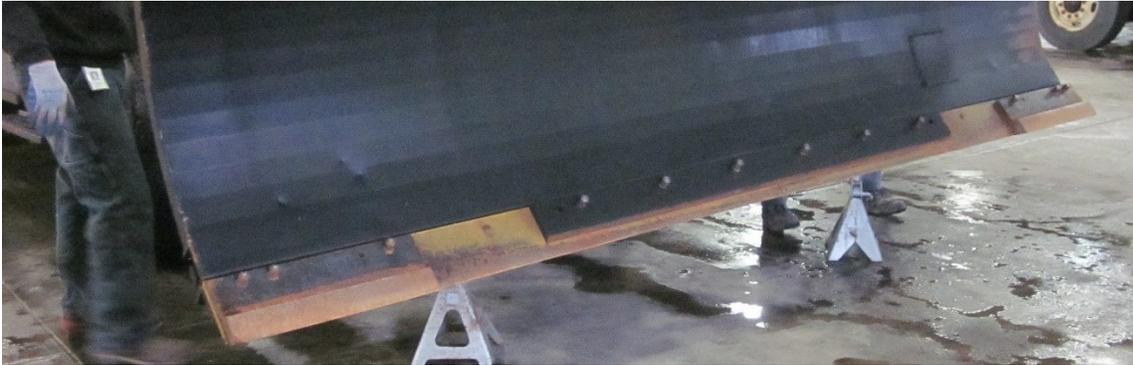
**Figure 2-6: Straight Blade**

As seen in Figure 2-6, a straight blade is one cohesive piece blade with no breaks. A straight blade is typically more difficult to install as compared to articulating blades. Additionally, straight blades are less expensive than articulating blades. Articulating blades, as seen in Figure 2-7, are segmented lengths of plow blades of carbide, steel, and hybrids usually encased in rubber. Segmented blades tend to adhere to the road more closely than straight blades and prevent damage from roadway obstructions (Bartuseck 2016). Aside from having multiple options of plow blade orientations, there are also a variety of plow blade material compositions.

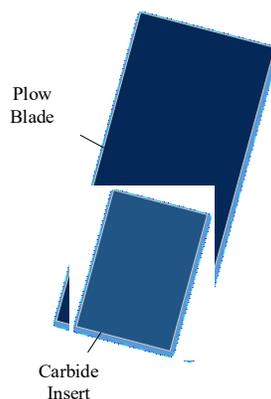
**Figure 2-8: Carbide Insert**

The first plow blade material typically selected by DOTs is steel. Steel is inexpensive, but it has the potential to snap when hitting obstacles (Nixon 2012), is difficult to install and remove, and wears faster than other materials (Snow & Ice Control Guidebook 2016). There are two varieties of steel blades: steel blades and steel blades with carbide inserts. Carbide inserts are used to increase steel blades' durability. Figure 2-8 shows how a carbide insert is configured into a plow blade.

As shown in Figure 2-8, a carbide insert is a part of a plow blade. These inserts may be added to any type of plow blade to help reduce wear given carbide's hardness and toughness (Garcia et al. 2018). Carbide inserts are cemented carbide. Cemented carbide is powdered carbide, typically tungsten carbide, mixed with a metallic binder, typically cobalt. Tungsten carbide is the hardest material available in the market, which has a hardness close to that of a diamond (Shemi et al. 2018). Due to this hardness, tungsten carbide should have a long wear life; however, it has a reduced ability to resist fracturing.

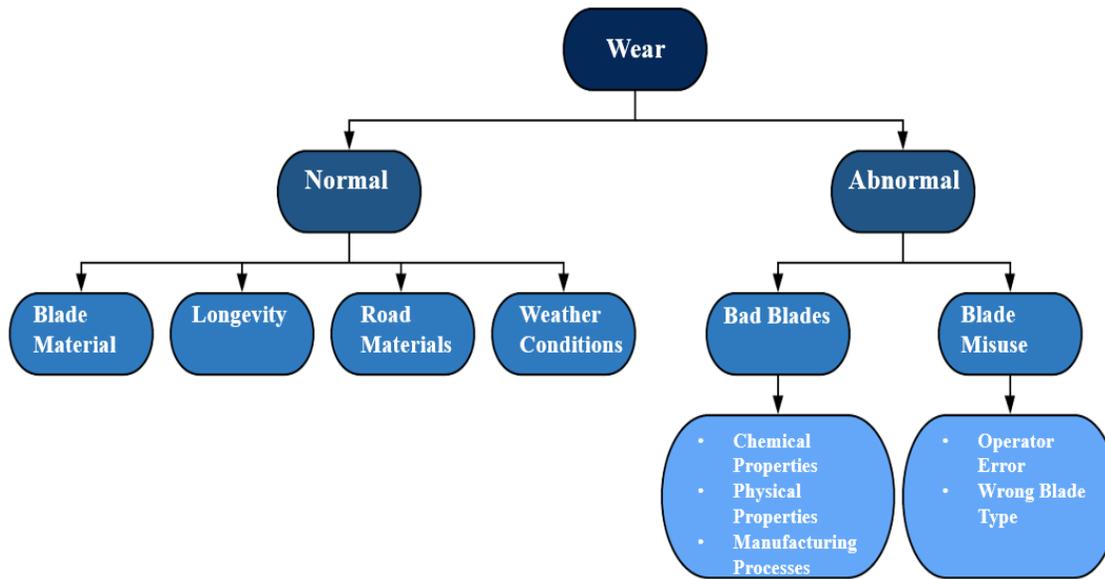
**Figure 2-9: Wear of Blades**

Wearing a plow blade may be categorized as normal or abnormal. Normal wear is due to an abrasive process through daily plowing. When a blade is no longer able to clear, it is considered a failure. (Jafari et al. 2018). Normal wear is expected meaning, it does not wear faster than anticipated; therefore, abnormal wear is when the blade wears faster than expected. Figure 2-9 shows the categorization of wear and its components.

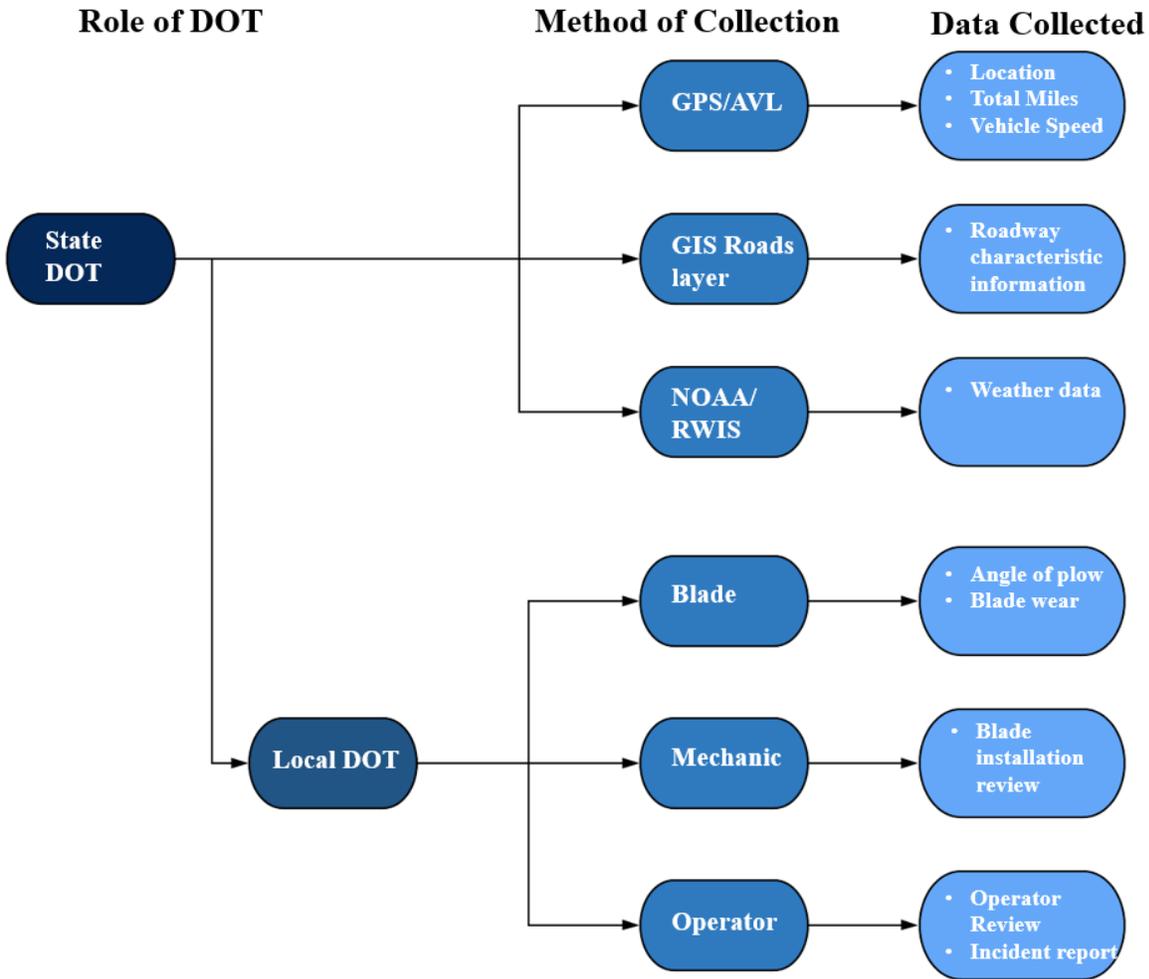
**Figure 4-1: Blade Testing Protocol**

Garages will provide the state coordination with blade, mechanic, and operator collected data. The sections below describe the deliverables, the frequency of delivery, and how the data should be transferred. The information expected to be collected may be seen in Figure 4-1.

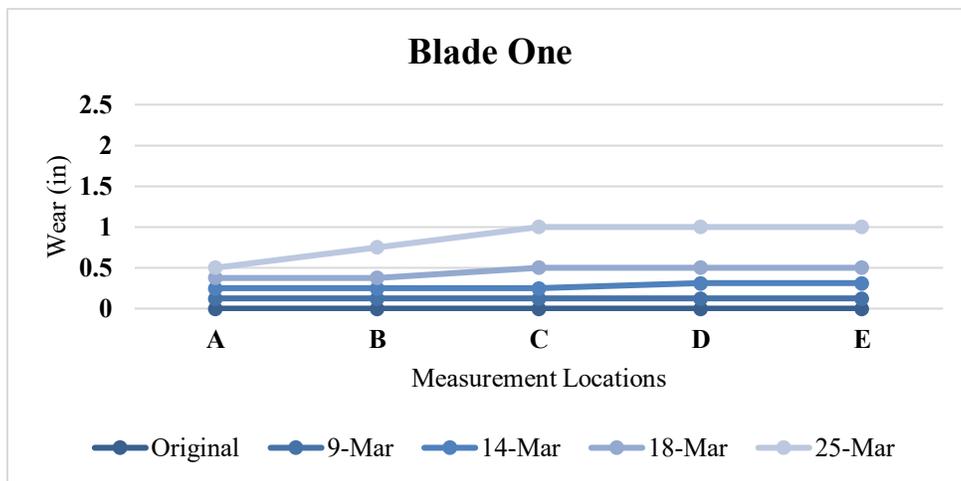
Figure 4-4: Blade One tested in Soda Springs

Table 4-10 summarizes the wear of blade one that is tested in Soda Springs, Idaho. Figure 4-4 visually displays the wear summarized in Table 4-10. The average snow fall during the lifespan of the blade is 2.6” with an average ground snow of 3.3” (NOAA 2020). The average temperature while plowing is 31.2 °F with an average road temperature of 30.65 °F. This blade is utilized for 23 days and plowed 550.7 miles.

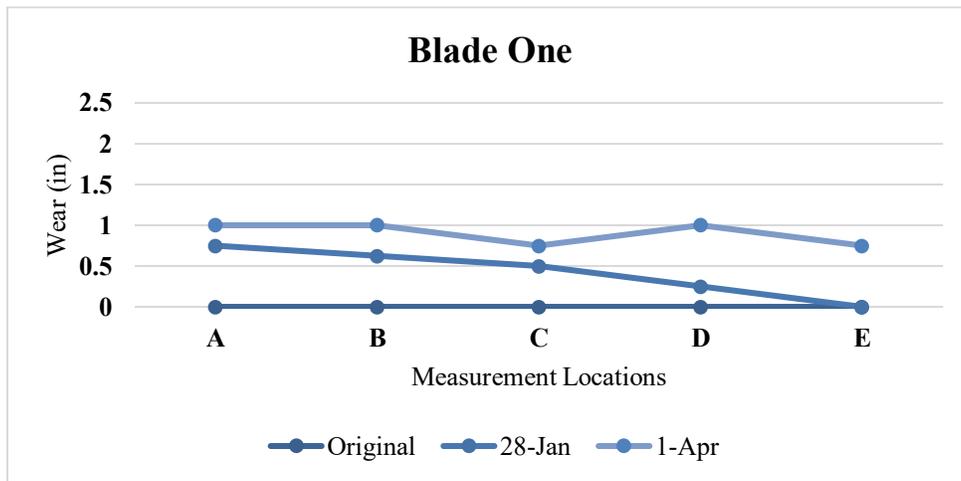
**Figure 4-5: Blade One Tested in Moscow/Potlatch**

Table 4-11 summarizes the wear of blade one that is tested in Moscow/Potlatch, Idaho. Figure 4-5 visually displays the wear summarized in Table 4-11. The average daily snow fall during the lifespan of the blade is 1.12" with an average daily ground snow of 3.7" (NOAA 2020). Snowfall and ground snow at the beginning of the season was higher than snowfall at the end of the season. The average temperature while plowing is 32.5 °F with an average road temperature of 34.8 °F. This blade is utilized for 82 days and plowed 1,753.1 miles. The x-axis represents the measurement locations. The y-axis represents the wear on the blade in inches.

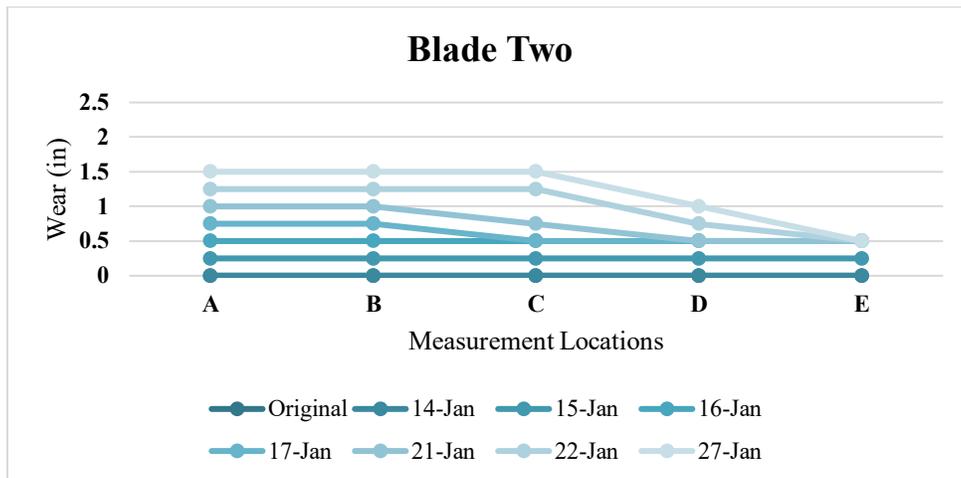
**Figure 4-6: Blade Two tested in Soda Springs**

Table 4-12 summarizes the wear of blade two which is ran in Soda Springs, Idaho. Figure 4-6 visually displays the wear of blade two at the predetermined locations along the blade. The average snow fall during the lifespan of the blade is 7.7" with an average ground snow of 8.0" (NOAA 2020). The average temperature while plowing is 22.7°F with an average road temperature of 24.2°F. This blade is utilized for 14 days and plowed 214.2 miles. The x-axis and the y-axis are the same as seen in Figure 4-5.

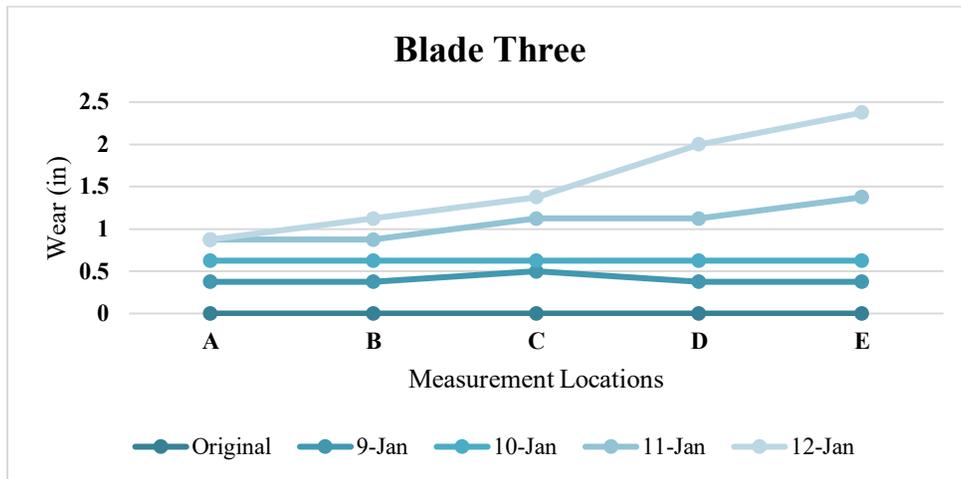
**Figure 4-7: Blade Three tested in Soda Springs**

Table 4-13 summarizes the wear results of blade three. Figure 4-7 visually displays the wear of the blade. This blade is run in Soda Springs, Idaho. The average daily snow fall during the lifespan of the blade is 1.4" with an average ground snow of 7.5" (NOAA 2020). The average air temperature while plowing is 26.8 °F with an average road temperature of 26.0 °F. This blade is utilized for 10 days and plowed 251.1 miles. The x-axis and the y-axis are the same as seen in Figure 4-5.

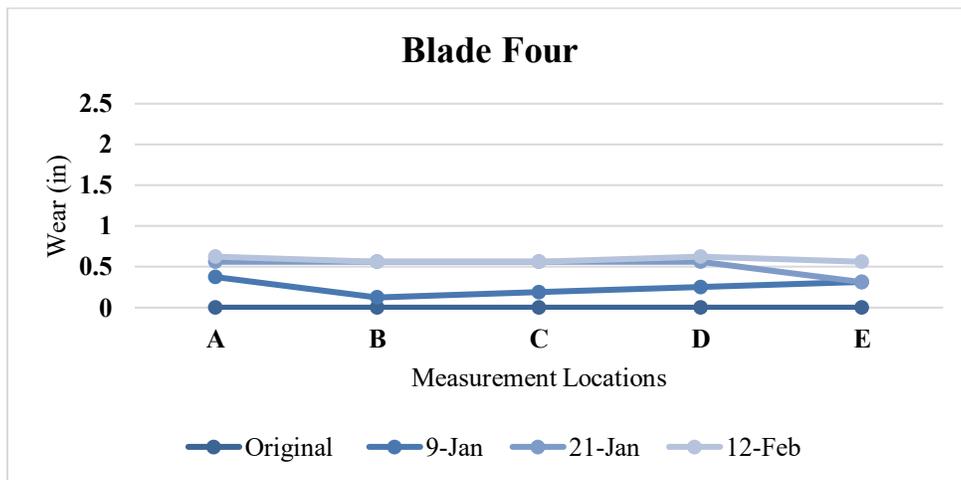
**Figure 4-8: Blade Four tested in Moscow/Potlatch**

Table 4-14 summarizes the wear results of blade four. Figure 4-8 visually displays the wear of the blade. This blade is run in Moscow/Potlatch, Idaho. The average daily snow fall during the lifespan of the blade is 1.1" with an average daily ground snow of 3.7" (NOAA 2020). The snowfall at the beginning of the season was much larger than the snowfall at the end of the season. The average air temperature while plowing is 26.9 °F with an average road temperature of 29.1 °F. This blade is utilized for 91 days and plowed 375.3 miles. The x-axis and the y-axis are the same as seen in Figure 4-5.

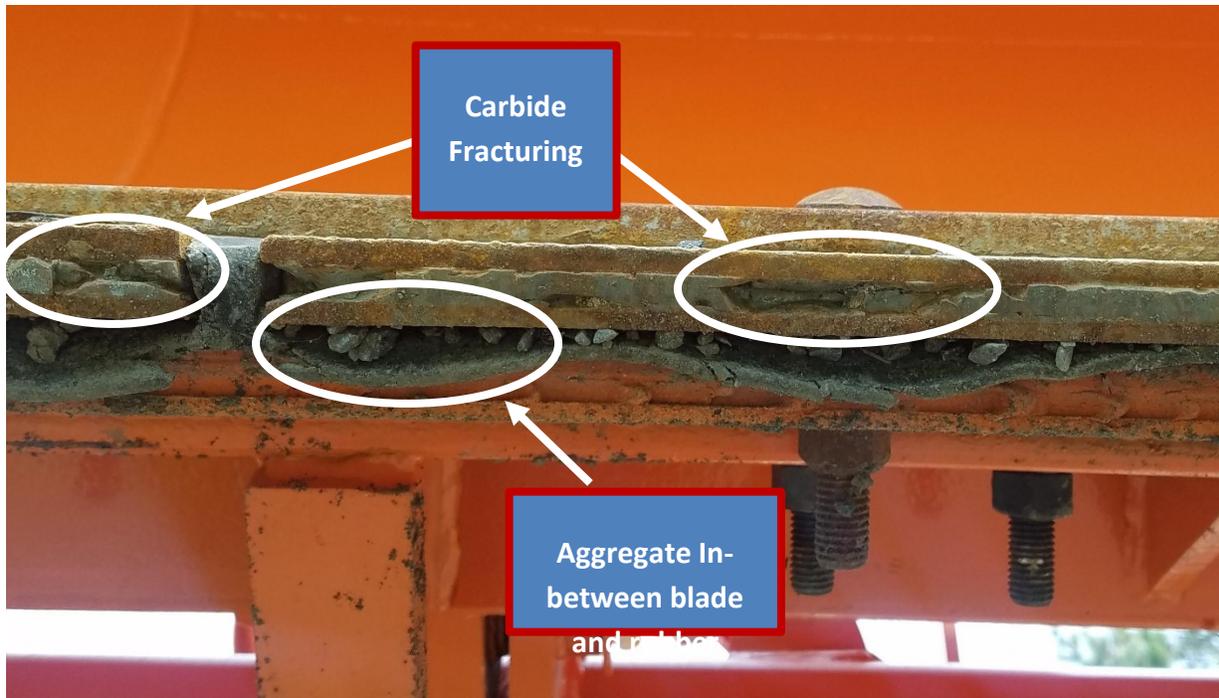
**Figure 4-9: Blade Failure in Idaho Case Study**

As seen in Table 4-15, blade one costs \$192.46/100 miles. This blade had failure due to chipping within the carbide insert and gravel located between the rubber and the steel blade. It may be seen in Figure 4-9.

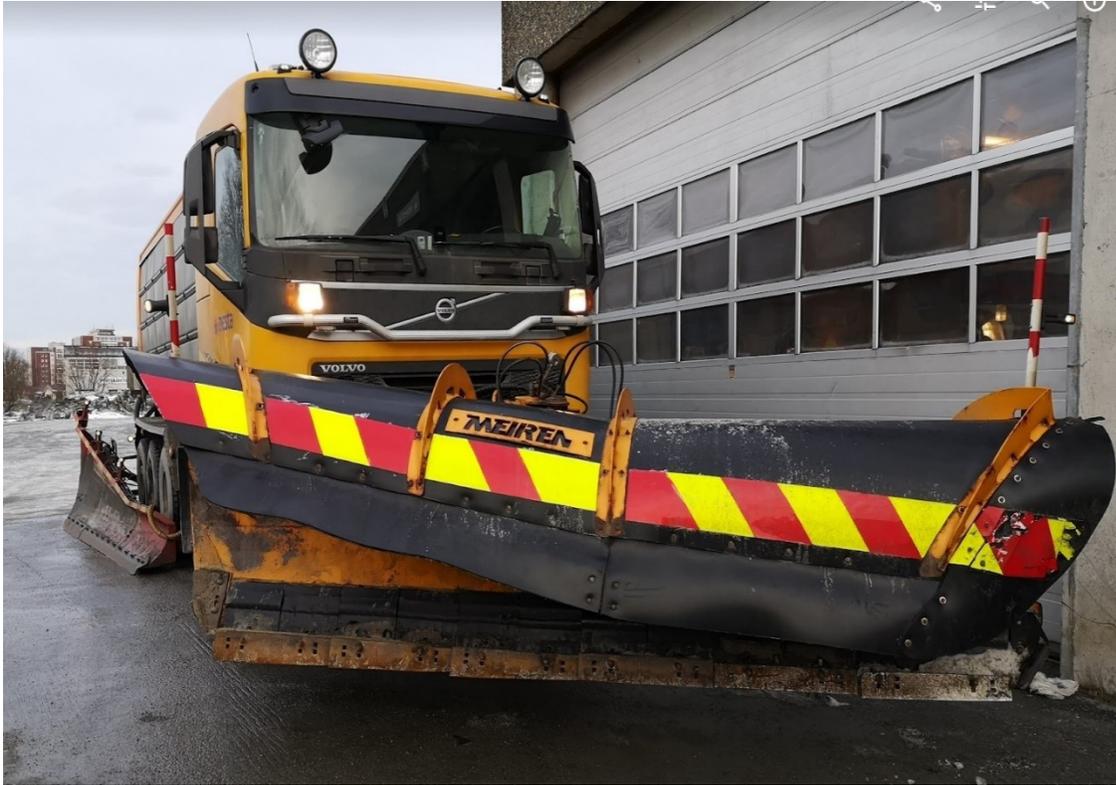
Figure 4-11: Mesta Snowplow in Trondheim, Norway.

Blades were tested on 13 miles of a four-lane highway including ramps in Trondheim Norway by a private contractor, called Mesta. The blades were fitted on one snowplow truck, equipped with a Meiren MSP front plow. This truck was solely used for snow plowing on the 13 miles route, throughout the season and therefore ideal for a comparative test between two types of blades. Figure 4-11 displays the used snowplow fitted on the truck.

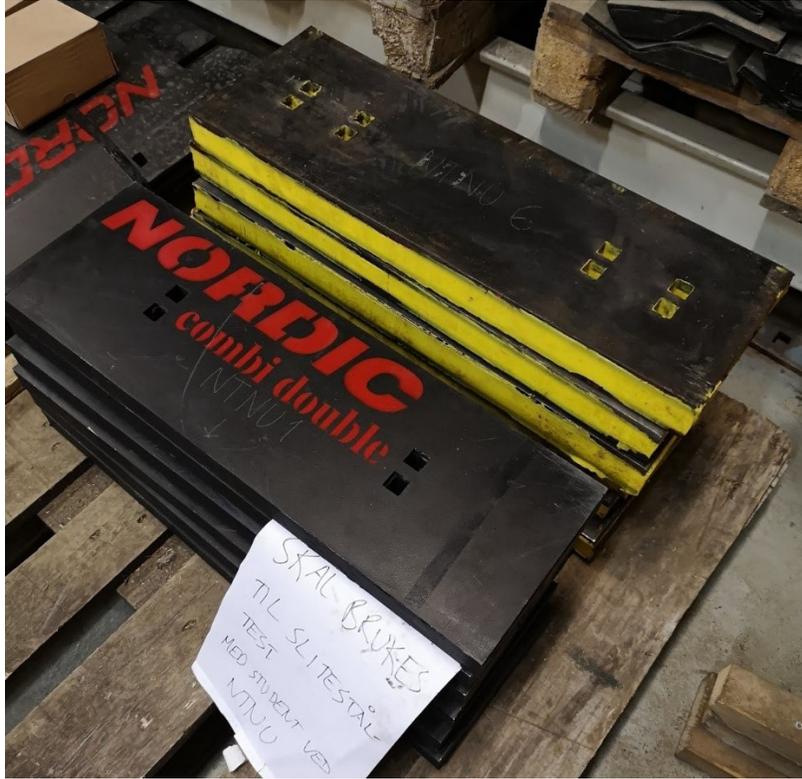
**Figure 4-12: Two Blade Types tested in Trondheim, Norway.**

The first type of blades were steel blades with rubber and ceramic inserts, called Nordic combi double. The second type was of blades had a core of Polyurethane, sandwiched between two steel plates. Both blades were reversible, meaning that the blades can be worn down from one side first, and then rotated 180 degrees, to be worn off from the other side. The blades are illustrated in Figure 4-12 and one set of blades consist of six 2-foot blade elements. Since each blade set could be worn off from both sides they were marked as A1, A2, B1, B2, etc. The capital letter marks a given blade that was installed and number "1" refers to the first side that was worn down, and "2" refers to the second side.

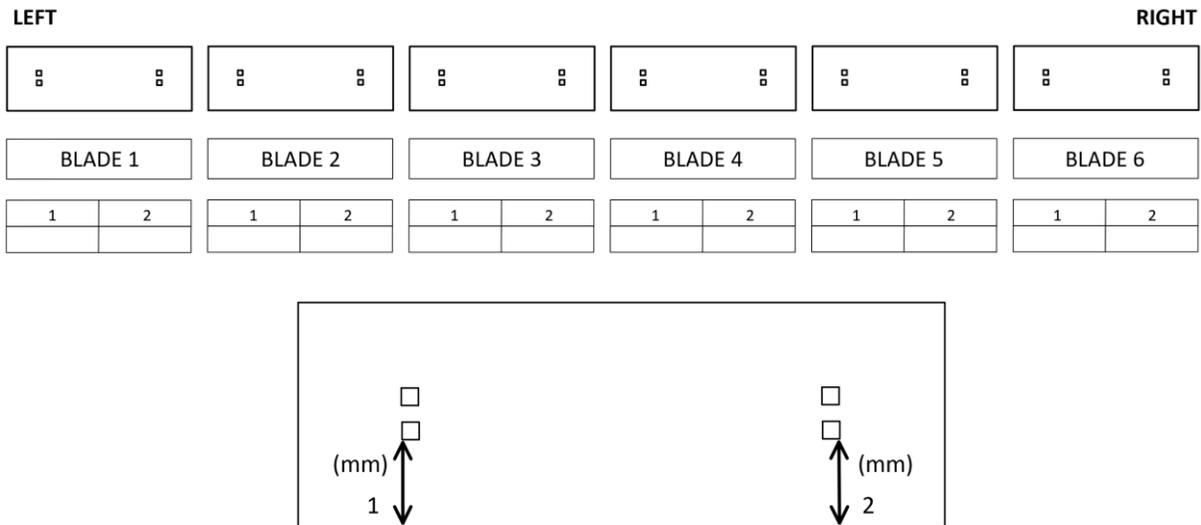
**Figure 4-13: Measurement Locations along a Blade in Trondheim, Norway**

For this small-scale field study, the research team and cooperating contractor wished for a more detailed dataset of the wear along the plow. The number of datapoints in the test protocol were therefore increased from 5 to 12. This provided two measurements per 2-foot blade. The lowest mounting holes were used as accurate reference point for the wear measurements, while the blades were fitted to the plow by bolts through the upper holes, illustrated in Figure 4-13.

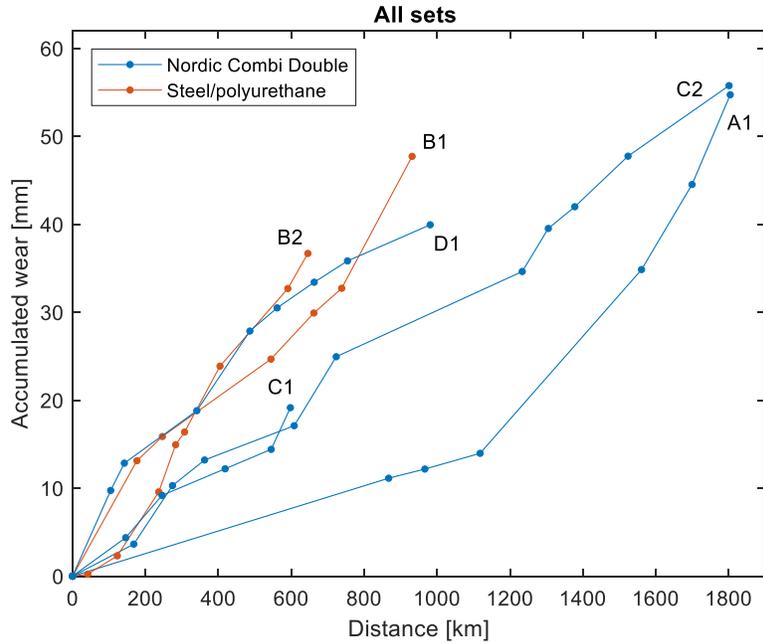
**Figure 4-14: Accumulated Wear as a Function of Plowing Distance**

1000 km plowing, Blade set A1 had only 12 mm wear, whereas D1 had worn 40 mm. The wear rate (= the steepness of the line between two successive measurement points) vary greatly, both within the same blade set and between different sets of the same type.

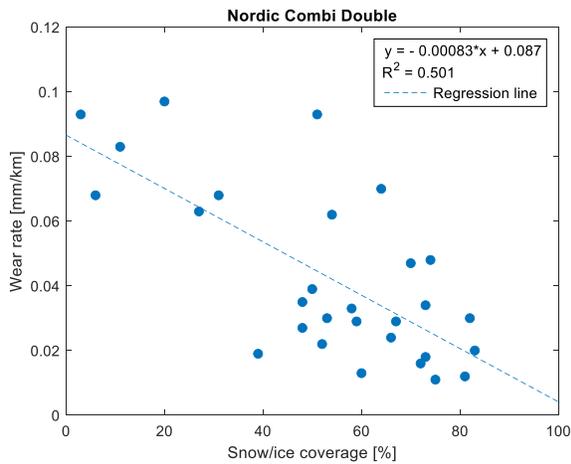
**Figure 4-15: Correlation of Wear Rate and Snow/Ice Coverage for Nordic Combi Double Blades**

Weather / road surface factor	Goodness of fit (R <sup>2</sup> )	
	Nordic Combi Double	Steel / Polyurethane
Amount of snowfall (mm)	0.125	0.055
Road surface temperature (°C)	0.137	0.018
Air Temperature (°C)	0.104	0.096
Relative Humidity (%)	0.013	0.030
Snow/ice Coverage (%)	0.501	0.423

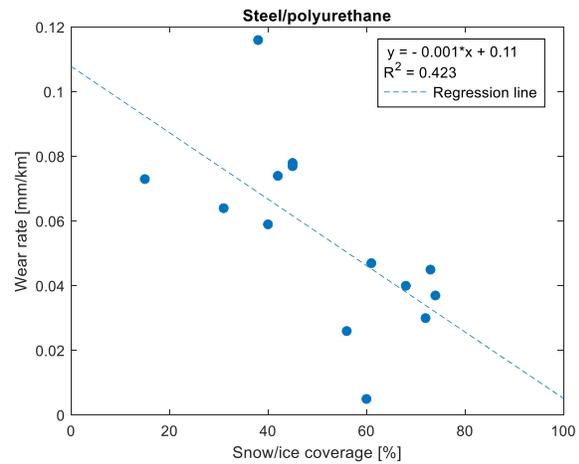
**Figure 4-16: Correlation of Wear Rate and Snow/Ice Coverage for Steel/Polyurethane Blades**

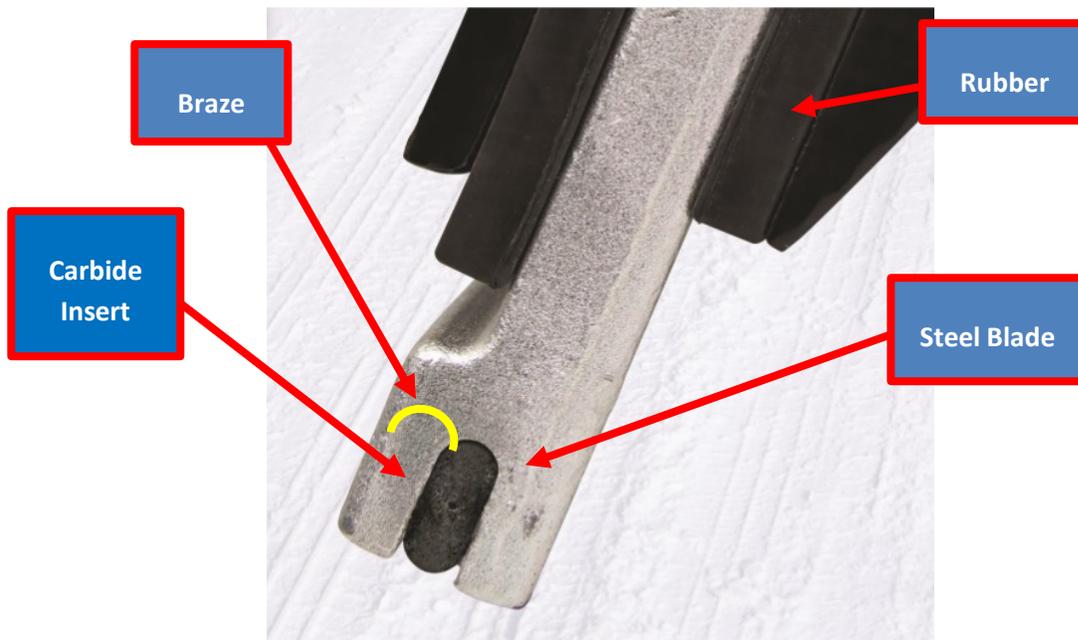
Figure 4-17: Polarflex Blade (Polarflex 2020)

The materials of the blades should be tested to ensure the specifications provided by the vendor are true and representative. Carbide, steel, and rubber have distinct tests due to the different chemical, physical and mechanical properties of each materials. Section 4.6.3 through 4.6.6, the individual specifications, test methods, and costs are suggested for braze, carbide, rubber, and steel, respectively. Figure 4-17, for example, is a flexible carbide blade that encompasses all the blade materials.

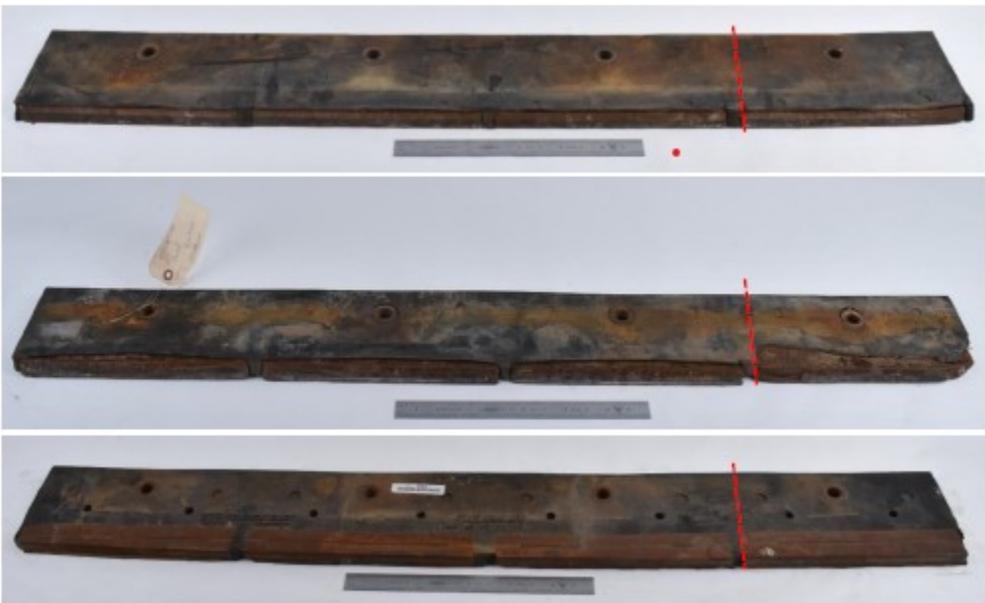
**Figure 4-18: Submitted Plow Blades**

The North Dakota – New, North Dakota – Used, and Iowa Blades are presented as received in Figure 4.18. Each of the blade’s exposed metallic components exhibited rust. Orange and white colored debris on the rubber surfaces of all three blades were observed.

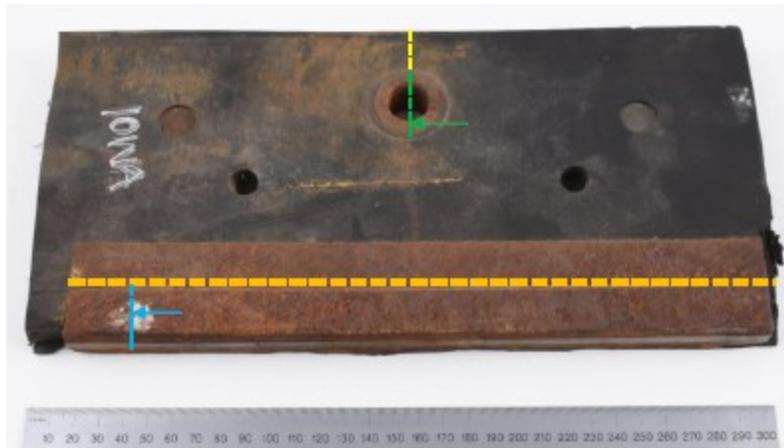
**Figure 4-19 Representative Blade Segment**

The North Dakota – Used Blade exhibited indications consistent with mechanical damage and abrasion of the blade components, which was consistent with the reported used condition. The components for the North Dakota – New and Iowa Blades appeared to be undamaged and showed no indications of use, which was consistent with the reported new condition. A section of each of the analyzed blades was excised along the dashed lines indicated in the view, to permit characterization of the individual metallic components within their respective blades. A closer view of a representative section is presented in Figure 4-19.

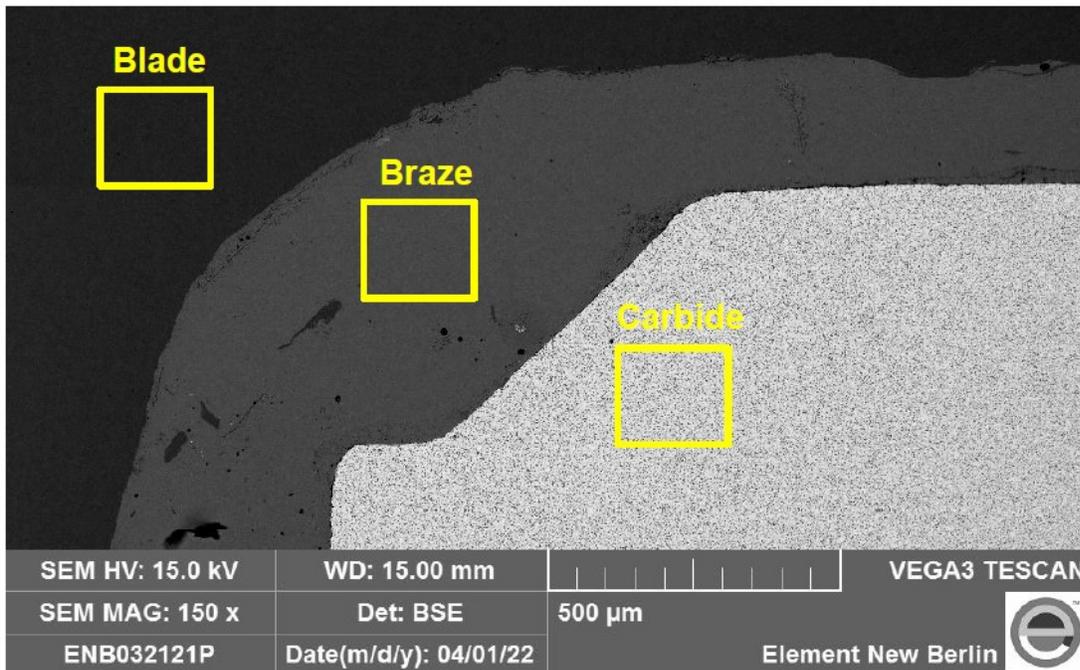
Figure 4-20: A BSE Scanning Electron Micrograph

A BSE scanning electron micrograph of the North Dakota – New cross-section is presented in Figure 4-20.

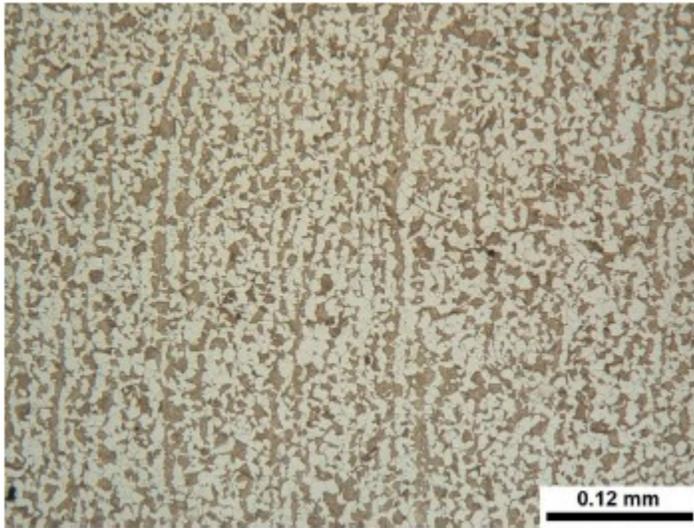
**Figure 4-22: A Digital Photomicrograph North Dakota**

Metallographic cross-sections prepared from the Blade/Carbide assemblies, for the North Dakota – New and Iowa Blade components, at the approximate planes of intersection represented by the blue dashed lines in Figure 4-19, are presented in Figures 4-22 and 4-23, respectively, revealing significantly different microstructures for the North Dakota – New and Iowa Blades.

*Note: A digital photomicrograph of the representative etched microstructure for the North Dakota – New Bridge component is presented. The microstructure consisted of pearlite and ferrite, with a ratio consistent with the analyzed chemistry. 2% Nital.*

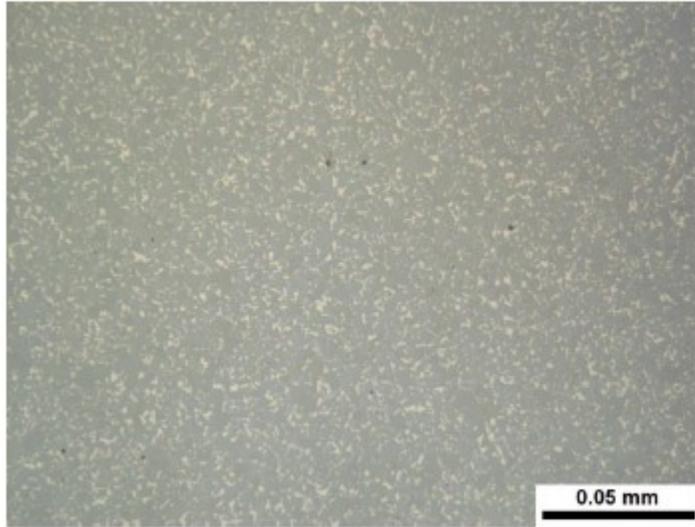
**Figure 4-24: A digital photomicrograph from North Dakota**

Evaluation of the Carbide microstructures for the North Dakota – New and Iowa samples, revealed relatively similar microstructures, consisting predominantly of tungsten carbides with a cobalt binder, which was consistent with the analyzed chemistries, as evident in Figures 4-24 and 4-25, respectively.

*Note: A digital photomicrograph of the representative unetched microstructure for the North Dakota – New Carbide component is presented. The microstructure consisted of predominately tungsten carbide with a cobalt binder, which is consistent with the analyzed chemistry. Slight staining of the sample was observed from etching of the North Dakota – New Blade component. As polished.*

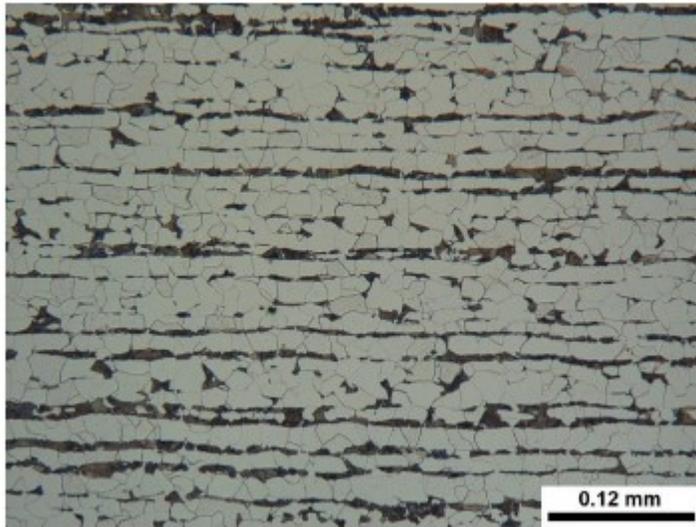
**Figure 4-26: A Digital Photomicrograph from North Dakota**

Digital photomicrographs of the Ring microstructures for the North Dakota – New, Iowa, and North Dakota – Used samples are presented in Figures 4-26 through 4-28, respectively.

*Note: A digital photomicrograph of the representative etched microstructure for the North Dakota – New Ring component is presented. The microstructure consisted of pearlite and ferrite, with a ratio consistent with the analyzed chemistry. 2% Nital.*

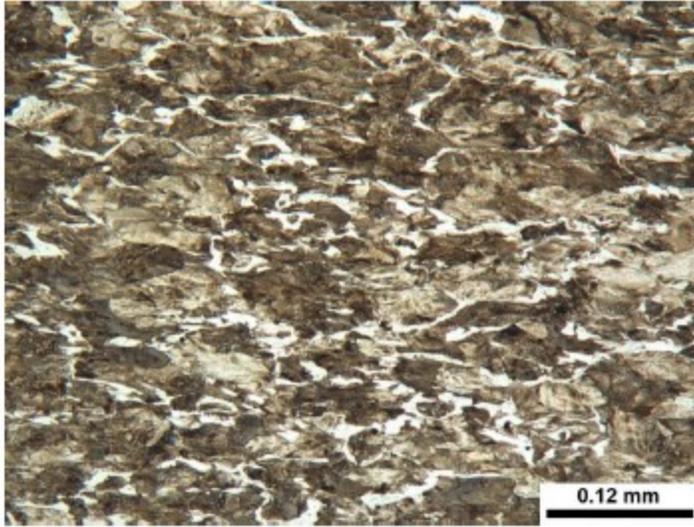
**Figure 4-27: A Digital Photomicrograph from Iowa**

*Note: A digital photomicrograph of the representative etched microstructure for the Iowa Ring component is presented. The microstructure consisted predominantly of pearlite with some ferrite, which is consistent with the analyzed chemistry. 2% Nital.*

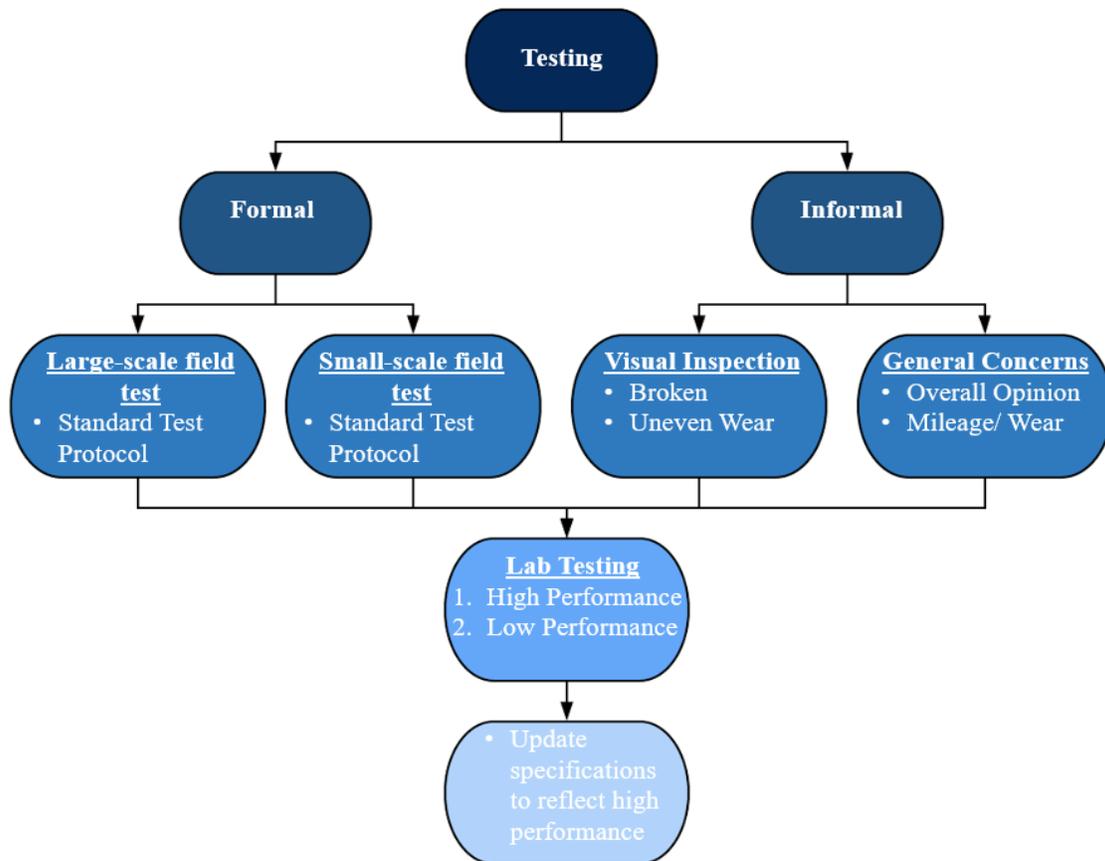
**Figure 4-39: Integration of Field and Lab**

of lab and field testing is seen in Figure 4-51 below.

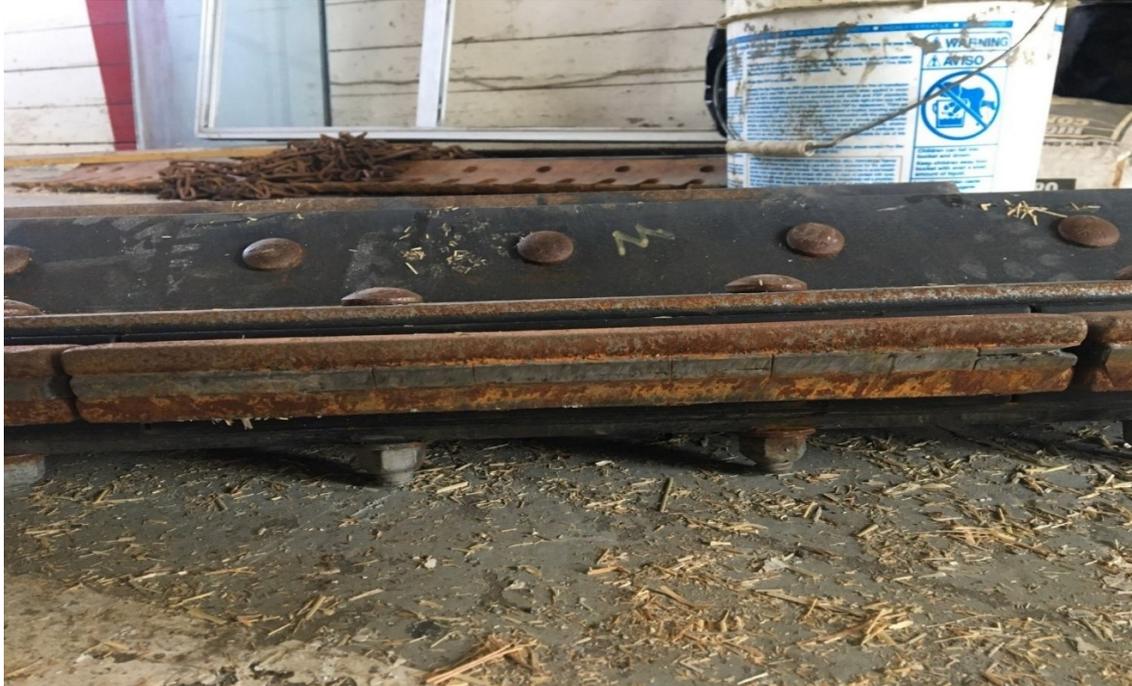
**Figure 4-40: Blade Four from the Idaho Case Study**

On the right side of Figure 4-39 is the informal testing of plow blades. Using this method may allow a DOT to conduct testing without costing time or finances. If a DOT would like to participate but does not have the ability to commit to a large scale or small-scale field test with lab testing, the research team recommends testing blades through visual inspections as seen in Figure 4-39. Visual inspection should be done on the front and underside of the blade. Figure 4-40 displays the underside of a blade that was tested in the Idaho case study.

Visual inspections should be done to see if blades are broken and wears unevenly. If the visual inspection indicates poor quality due to a bad blade, it is suggested to send the blade in for laboratory testing. The second informal testing method is general concerns which encompasses overall opinion and mileage/wear. Overall opinion may be monitored based off operator comments or mechanics comments. Once established that the blade is performing abnormally, the DOT should take measurements to monitor its performance as frequently as possible. If the measurements and frequency of changing a blade appear to be abnormal, it is recommended to send the blade in for laboratory testing.
